PROPERTY CONDITION REPORT

11021 West Pico Boulevard
11021 West Pico Boulevard
Los Angeles, California 90064

Report Date
September 11, 2023

Partner Project Number:
23-419894.1

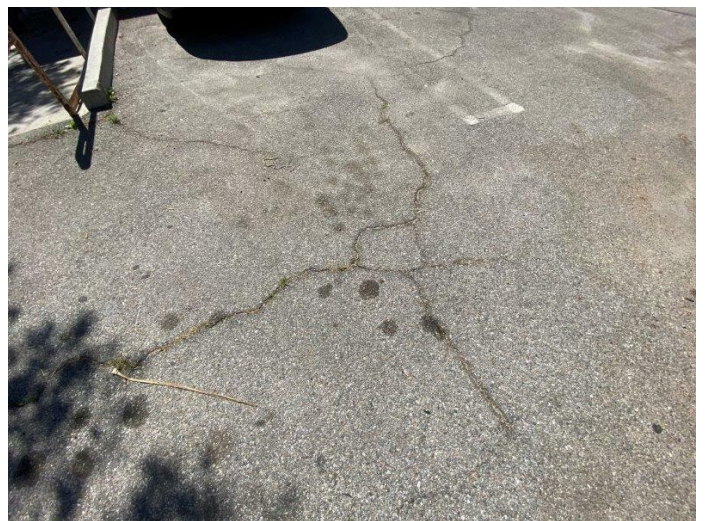
Asphalt pavement appeared to be in fair to poor structural condition. Various areas of linear cracking, map cracking, vegetation growth, and surface raveling were observed throughout the paved areas. Mill and resurface of the parking area is recommended. An opinion of cost for this work is included in Table 1.

6. Asphalt pavement condition

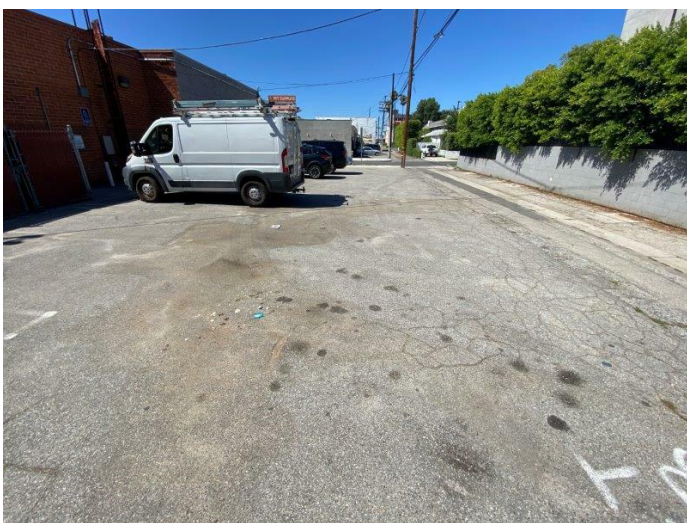
17. Asphalt pavement condition

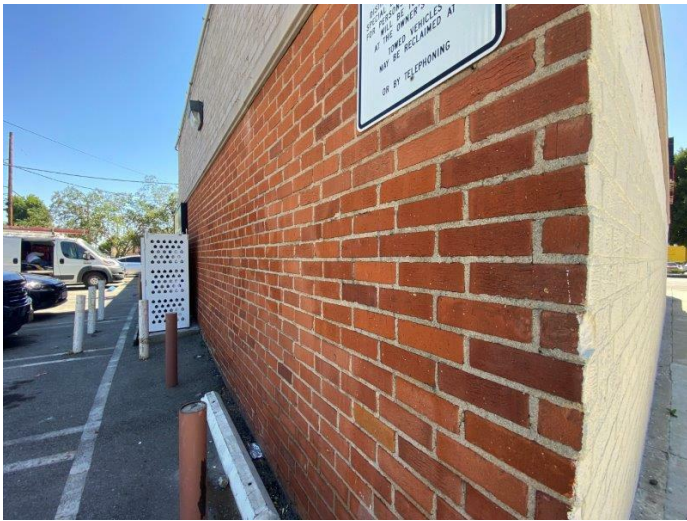
19. Brick masonry condition

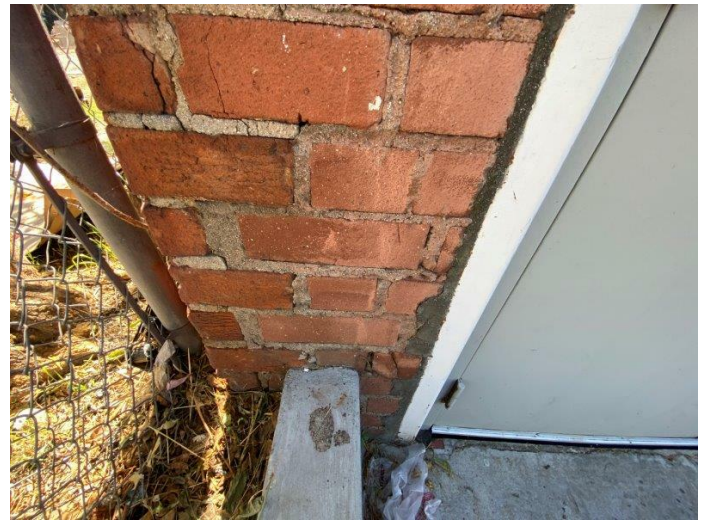
20. Brick masonry condition

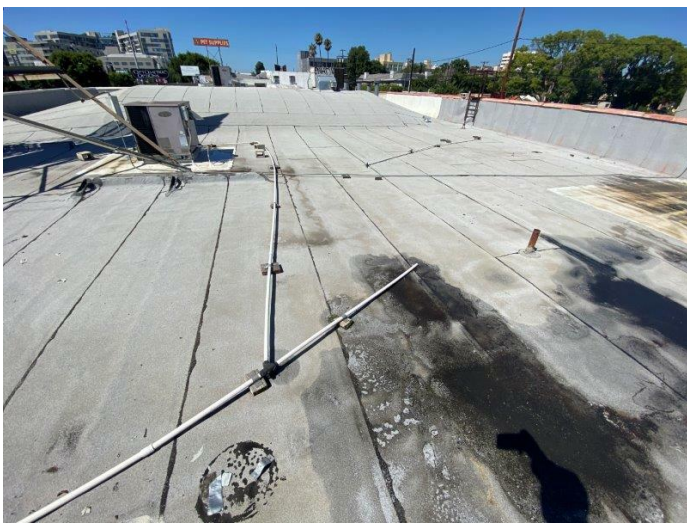
Isolated areas of ponding were noted. Ponding was observed at the northeast corner of the building and appeared to be the result of a damaged condensate line from the roof mounted HVAC equipment. Ponding typically occurs when the roof insulation or decking is not properly sloped to allow for complete drainage or water flow through the roof drainage system is impeded. Although ponding may decrease the useful life of the roof, decking and insulation repairs are not practical or recommended. The noted area should be monitored for accelerated deterioration and the damaged condensate line should be repaired. According to property management, maintenance and repair of the HVAC equipment is the responsibility of the building tenant, As such, no cost for this work has been allocated.

35. Damage HVAC condensate line and ponding on the building roof

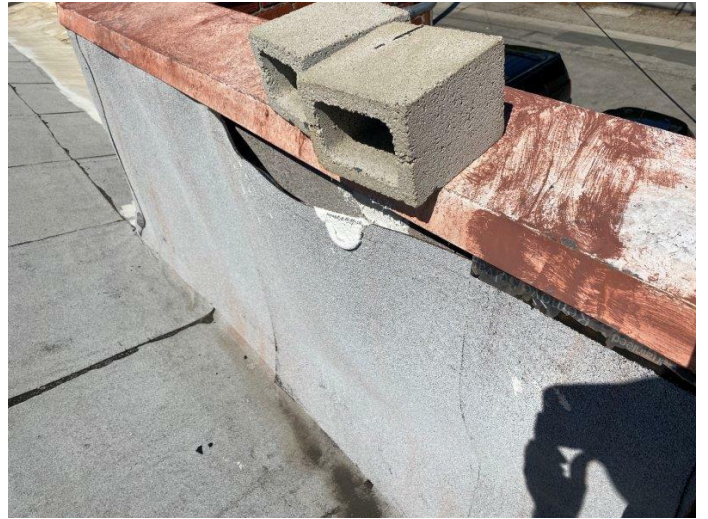
Parapets appeared to be in fair to poor condition. The roof materials were noted to be detached from the inboard side of the parapet wall at the northwest corner of the building. Immediate repair is recommended. An opinion of cost for this work is included in Table 1.

38. Material separation at the inboard side of the parapet wall

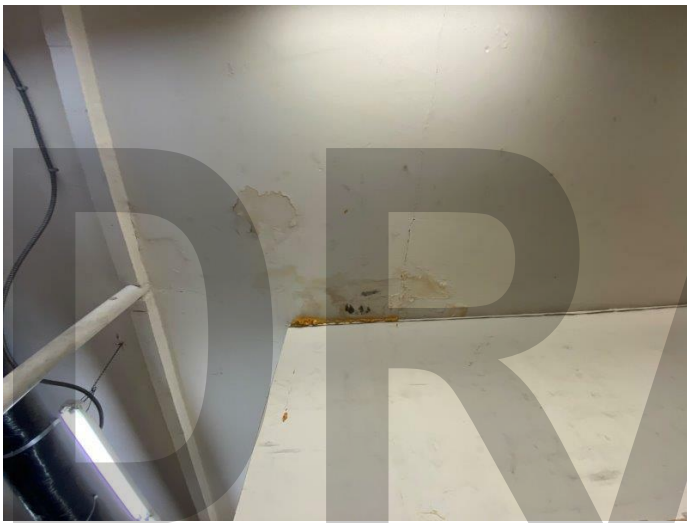
63. Staining at ceiling

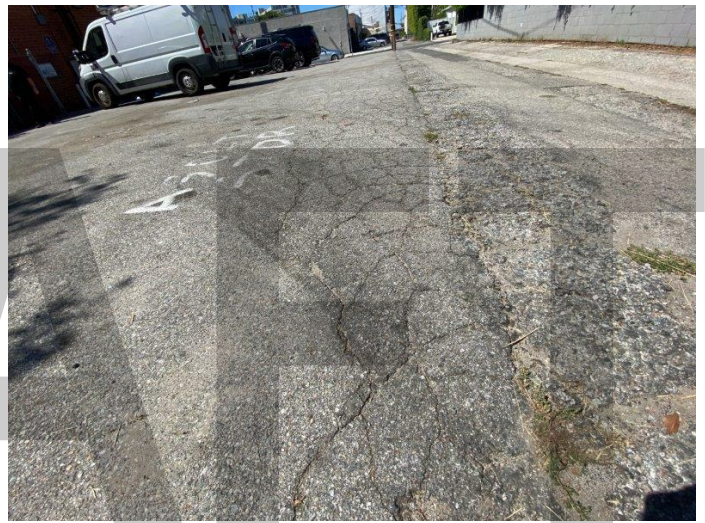
64. Asphalt pavement condition

3.0	Site Improvements						
3.2.2	Various areas of linear cracking, map cracking, vegetation growth, and surface raveling were observed throughout the paved areas. Mill and resurface of the parking area is recommended.	3,500	SF	\$6.00	\$21,000		\$21,000

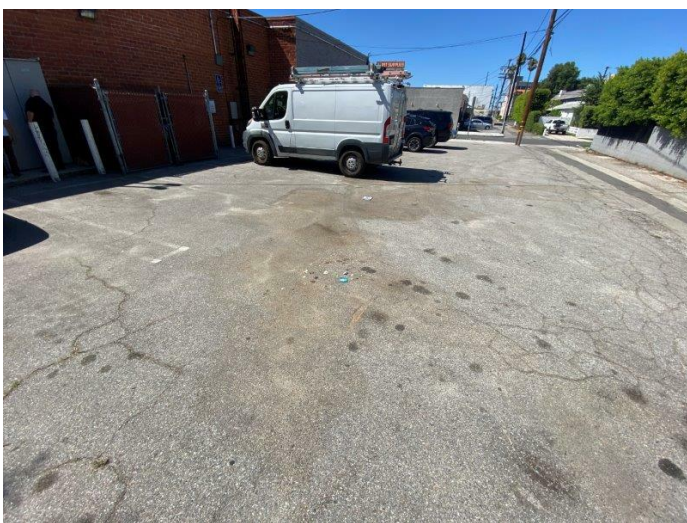
65. Asphalt pavement condition

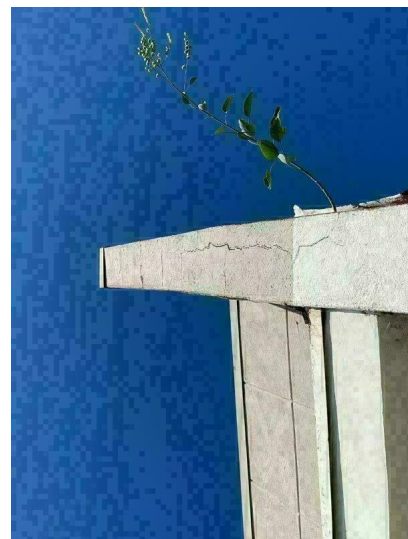
The exterior walls appeared to be in generally fair condition. The southeast corner of the building has a vertical crack in the brick approximately two to three feet in height near at the parapet and instances of vertical cracking in brick further below within the main portion of the exterior wall. The northwest corner has a crack and loose course brick near the base of the façade from possible vehicular impact. Repairing the brick, sealing cracks, and shoring the parapet are recommended, however, the actual repairs should be determined by a structural engineer. Refer to Section 2.3 for additional discussion. For planning purposes, an opinion of cost for this work is included in Table 1. Monitoring the façade for additional cracking is

66. Vertical cracking at the southeast corner of the building

4.0	Structural Frame and Building Envelope						
4.3.1	The southeast corner of the building has a vertical crack in the brick approximately two to three feet in height near the roof of the building and the northwest corner has a crack and loose course brick near the base of the façade. Repairing the brick, sealing cracks, and shoring the parapet are recommended.	1	Allowance	\$7,500	\$7,500		\$7,500

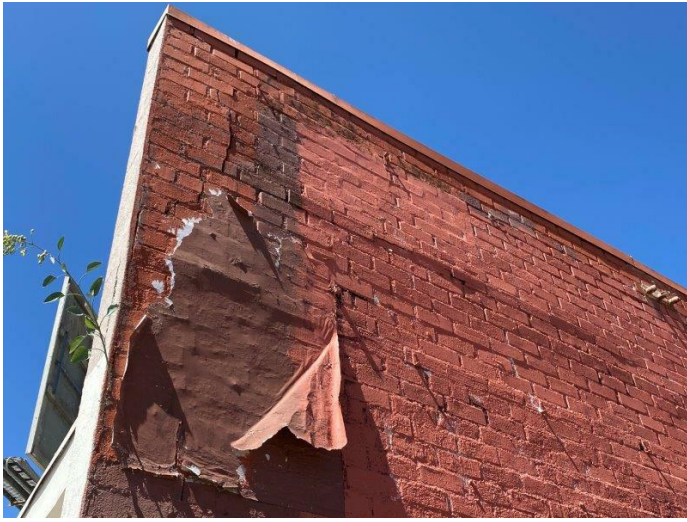
67. Cracking at the southeast corner

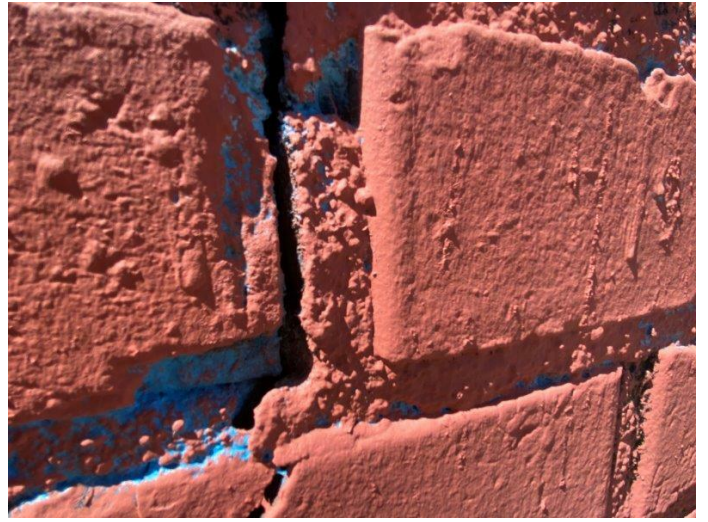
68. Cracking at the southeast corner

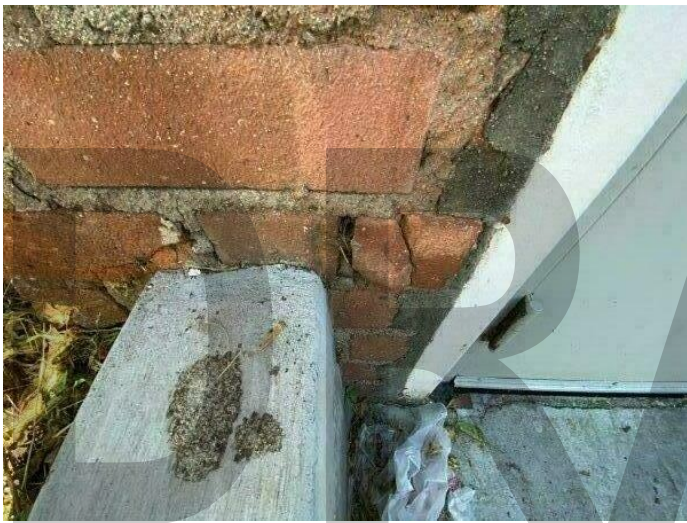
69. Instance of deteriorated mortar at northeast corner of the building

recommended during the evaluation period. Exterior cleaning and masonry pointing is anticipated during the evaluation period. An opinion of cost for this work is included in Table 2.

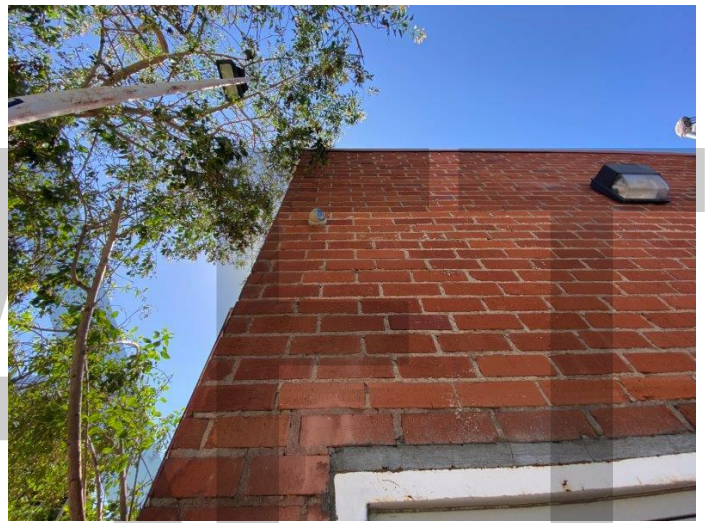
70. Tree encroaching on the building

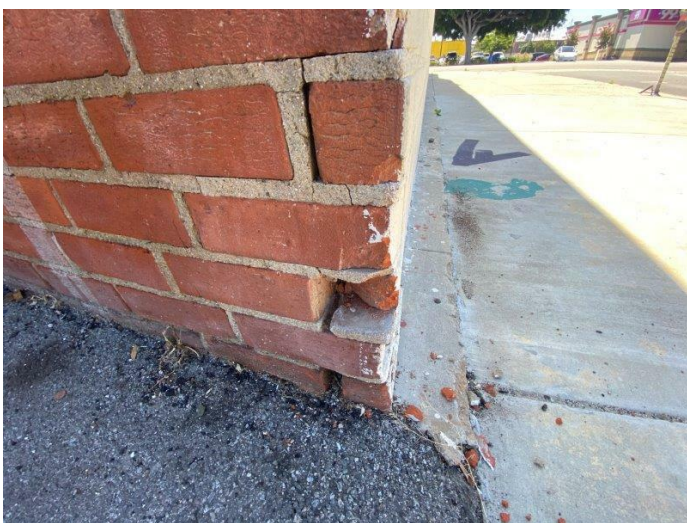
71. Damaged masonry on the northwest corner of the building

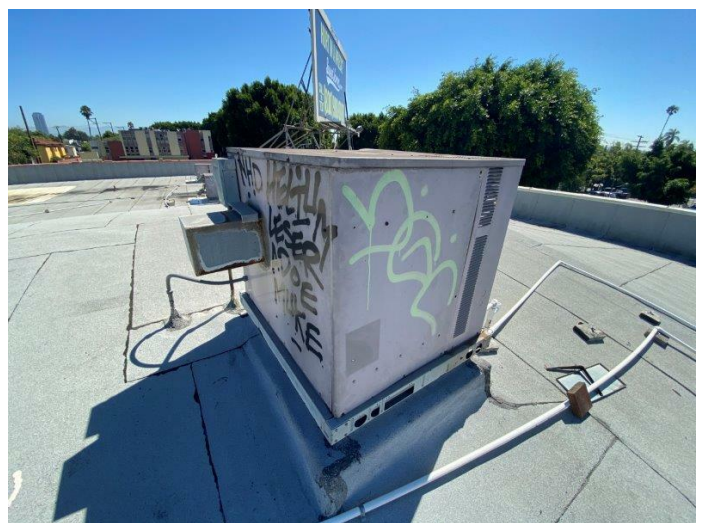
72. Single packaged heat pump beyond useful life (25 years old)

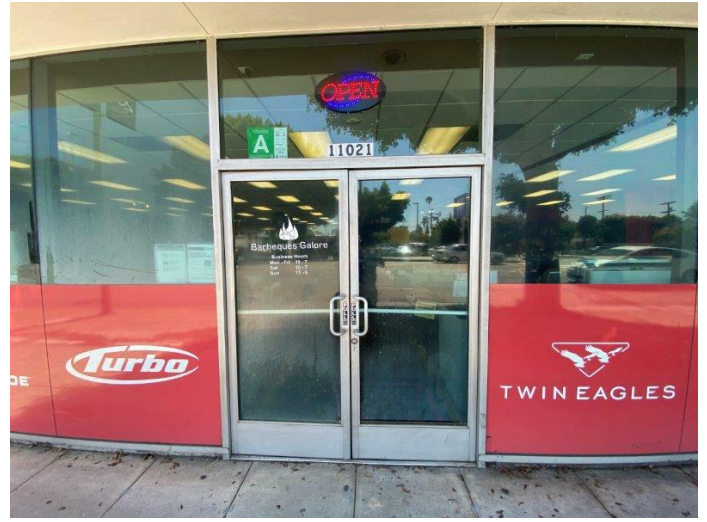
Windows were reported and appeared to be in good to poor condition. Fogged panes within the storefront system windows were observed at the main entrance to the Barbeques Galore tenant space. Replacement of the fogged panes is recommended. An opinion of cost for this work is included in Table 1.

Doors were reported and appeared to be in good to poor condition. Fogged panes within the storefront system entry doors were observed at the main entrance to the Barbeques Galore tenant space. Replacement of the entry doors is recommended. An opinion of cost for this work is included in Table 1.

74. Storefront system at the main entrance note address identification signage - note fogged panes at doors and windows

4.3.2	Fogged panes within the storefront system windows were observed at the main entrance to the Barbeques Galore tenant space. Replacement of the fogged panes is recommended.	1	Allowance	\$2,000	\$2,000		\$2,000

4.3.3	Fogged panes within the storefront system entry doors were observed at the main entrance to the Barbeques Galore tenant space. Replacement of the entry doors is recommended.	1	Allowance	\$2,000	\$2,000		\$2,000

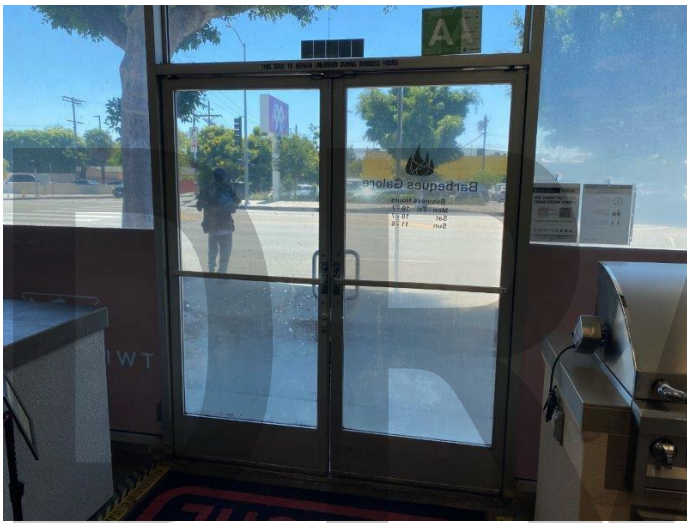
75. Fogged panes indicative of broken seals at storefront entry system
