PROPERTY CONDITION REPORT

11021 West Pico Boulevard
11021 West Pico Boulevard
Los Angeles, California 90064

Report Date
September 11, 2023

Partner Project Number:
23-419894.1

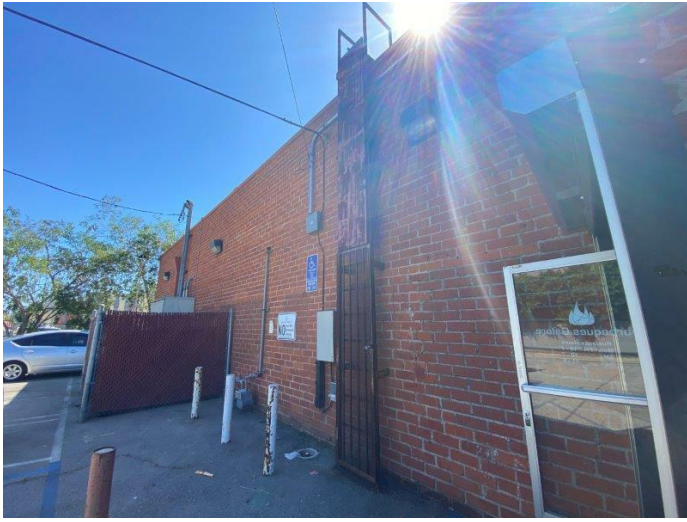
1. Northern exterior façade

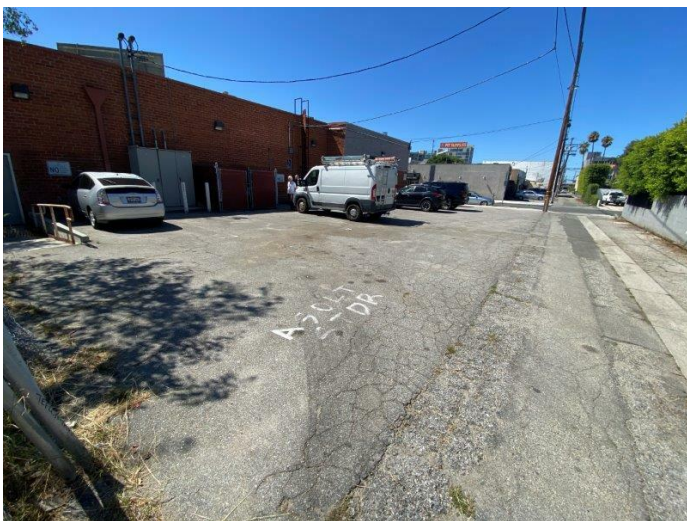
5. Overview of the asphalt paved parking area

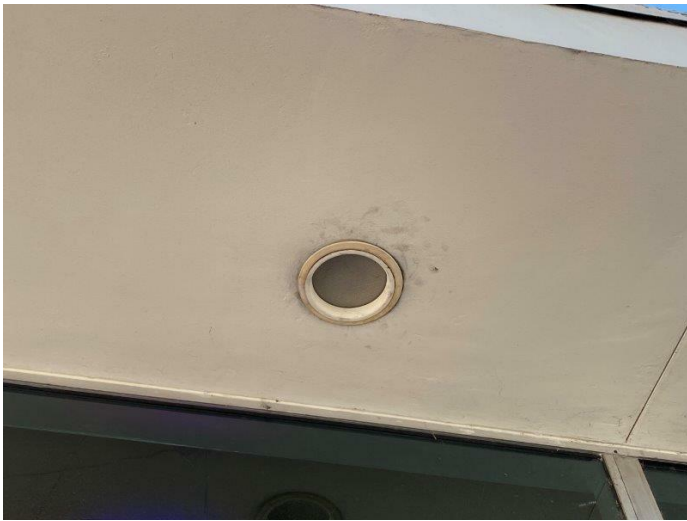
13. Soffit lighting component

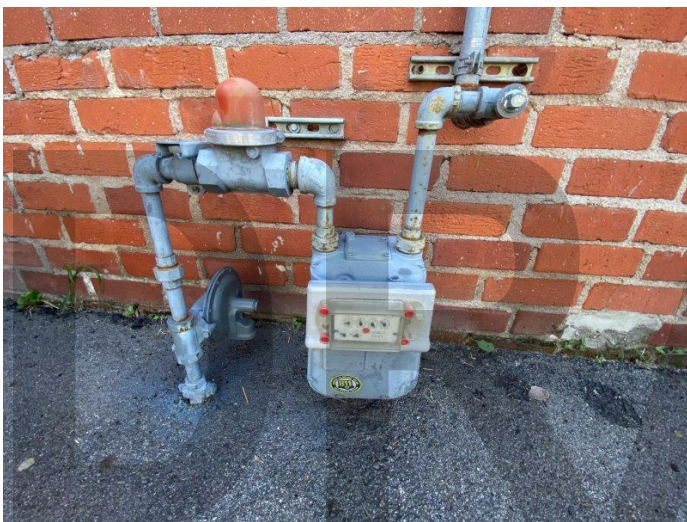
15. Natural gas connection with seismic shut off

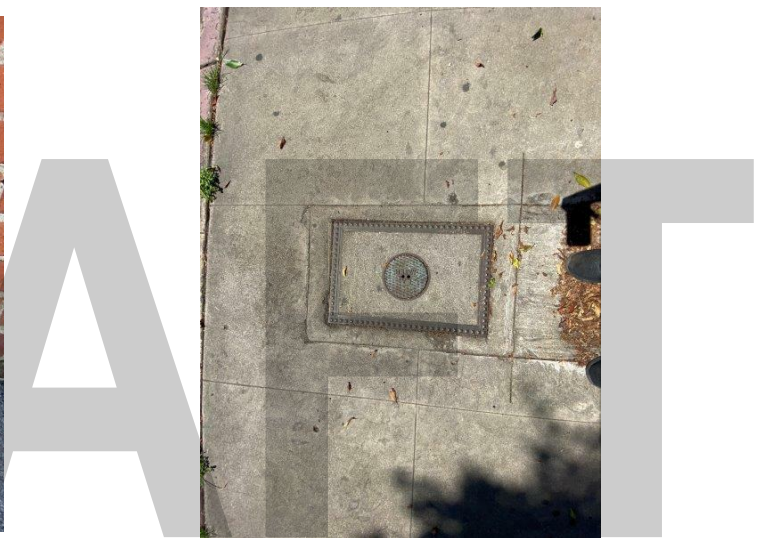
16. Water utility vault in the municipal sidewalk

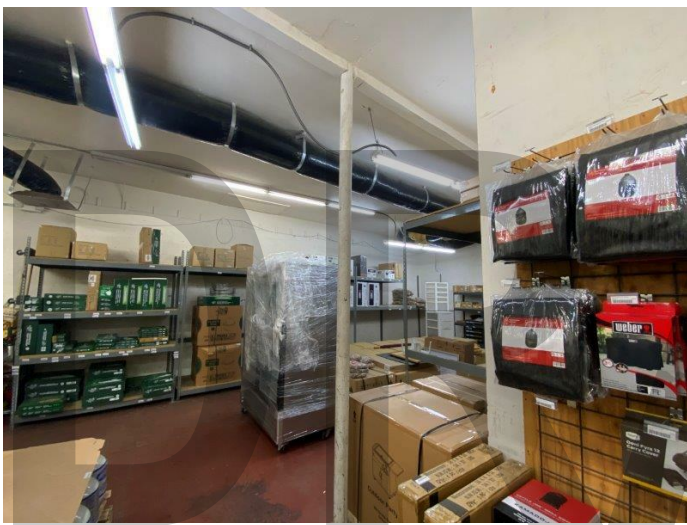
21. Structural component in the warehouse

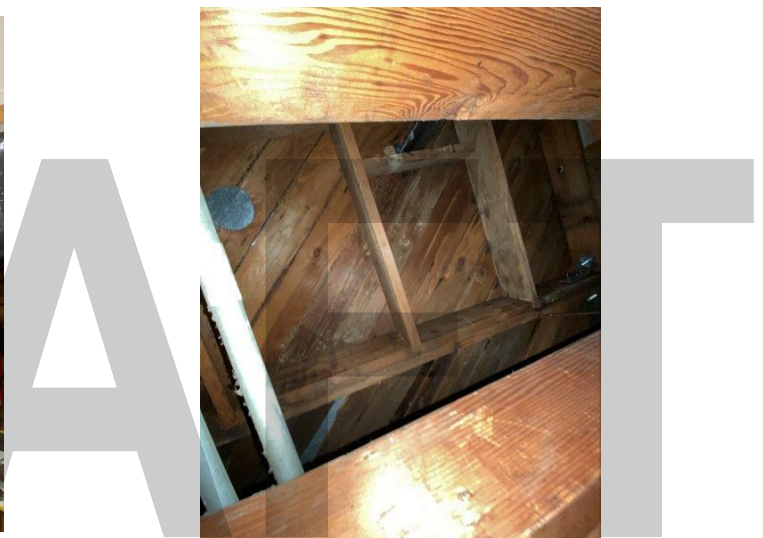
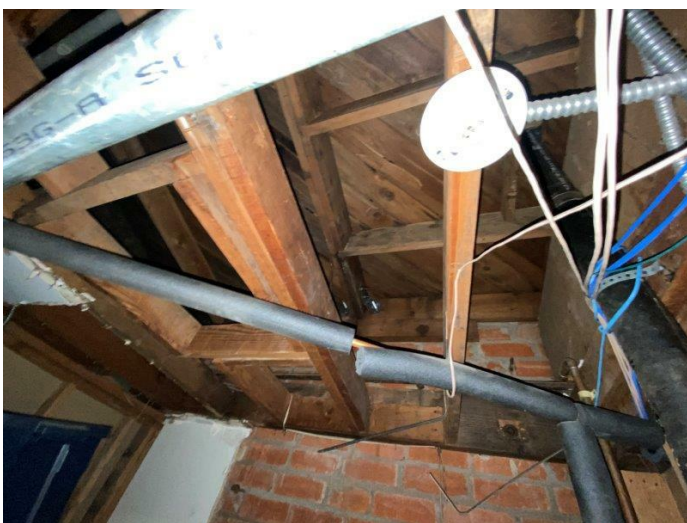
22. Roof framing elements

23. Roof framing elements

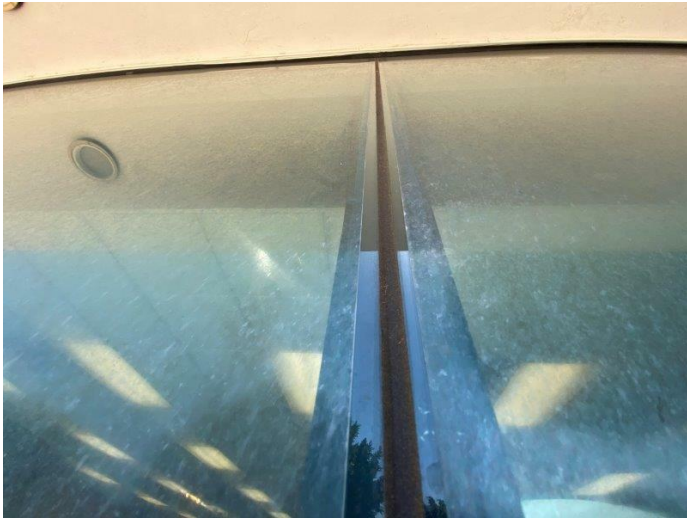
25. Window sealant condition

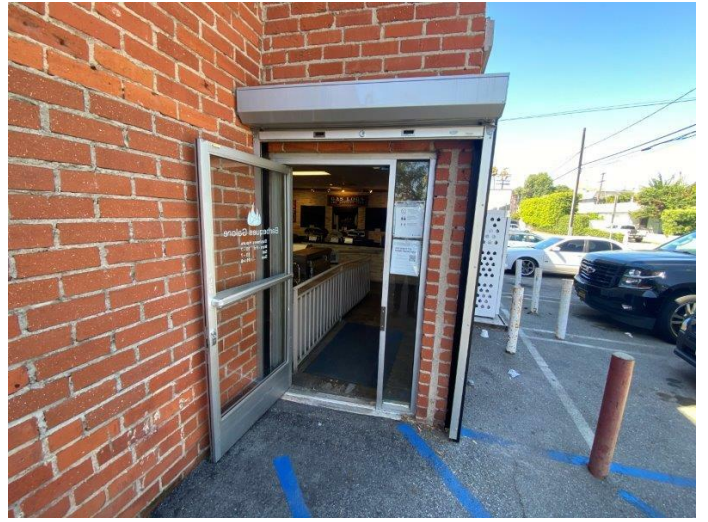
26. Secondary entry storefront system

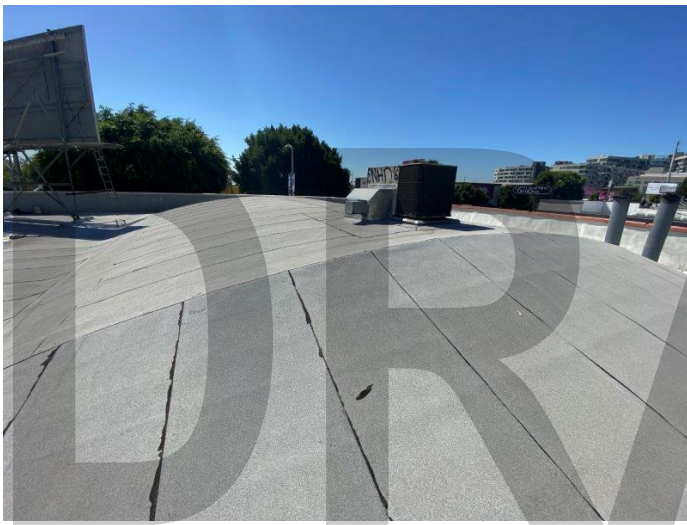
33. View of the bowed roof

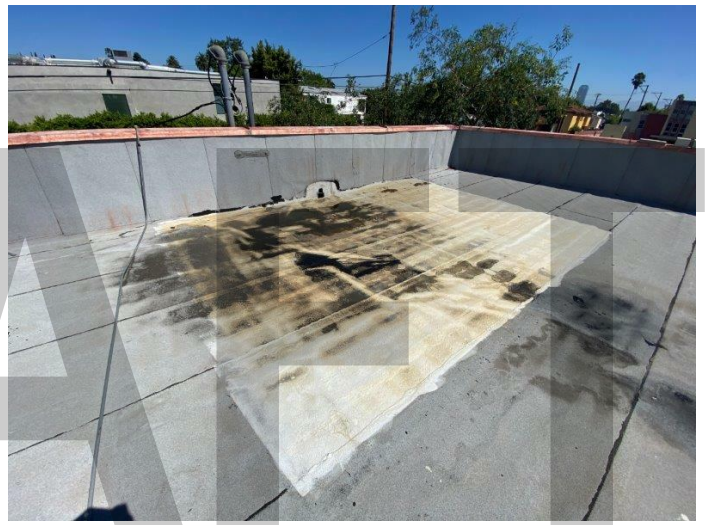
- Roof patching and repair work was completed in 2023; \$10,000

34. Area of recent roof repair

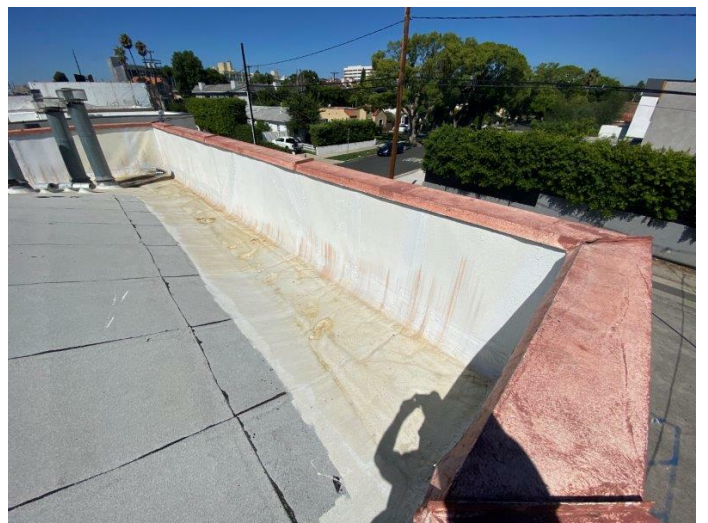
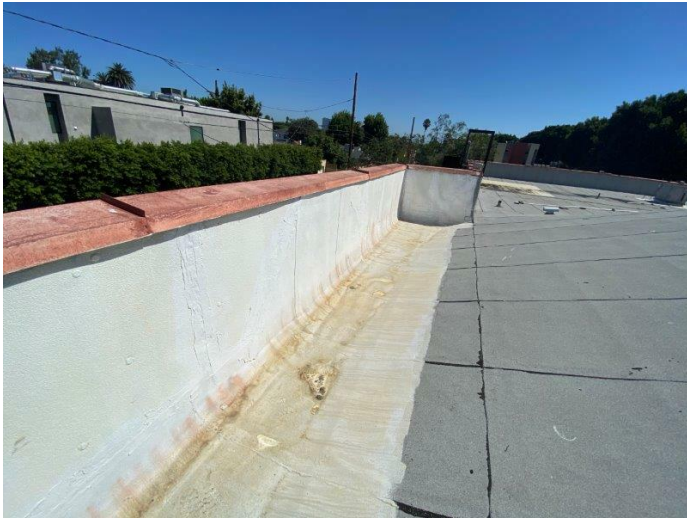
36. Parapet wall and area of recent repair on the northwest corner of the roof

37. Parapet wall and area of recent repair on the northwest corner of the roof

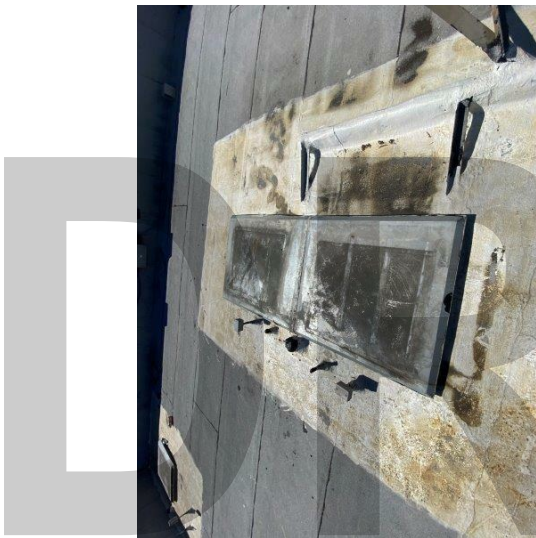
39. Area of removed HVAC equipment and recent roof repair

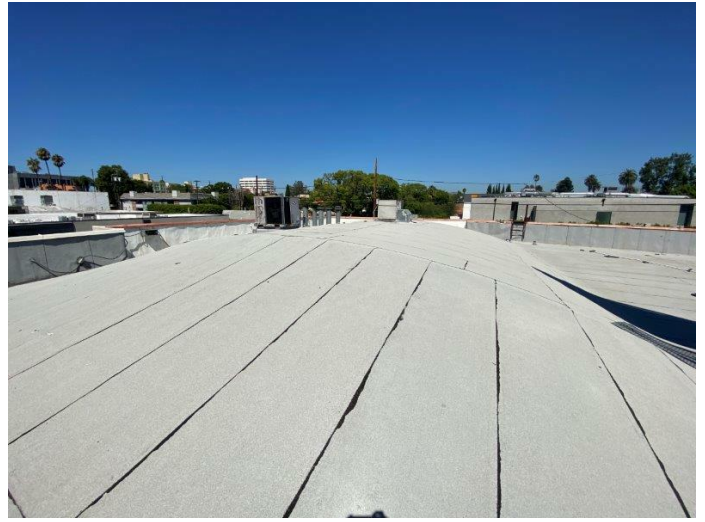
44. View of the roof field

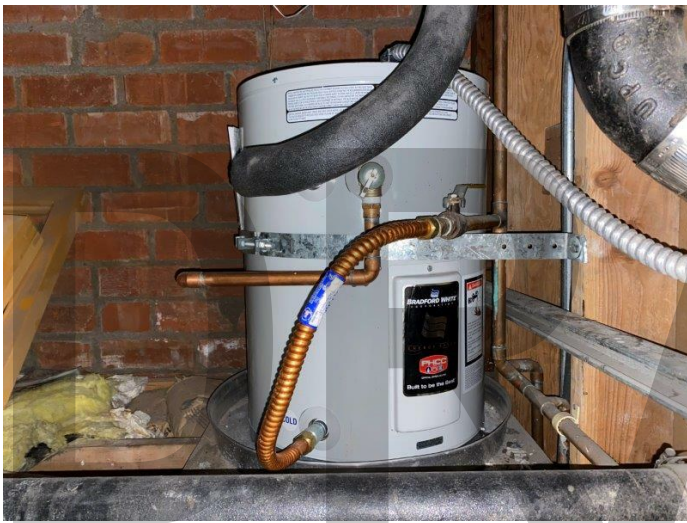
45. Hot water heater note copper supply piping (center/lower right) and cast iron sanitary waste piping (bottom)

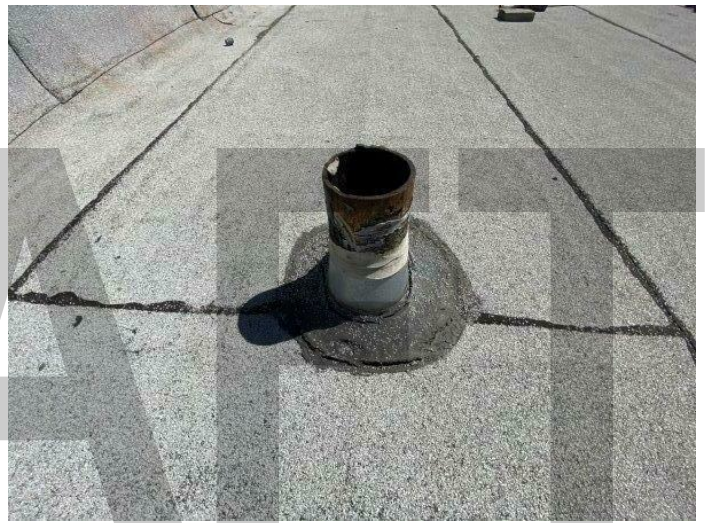
46. Sanitary vent piping

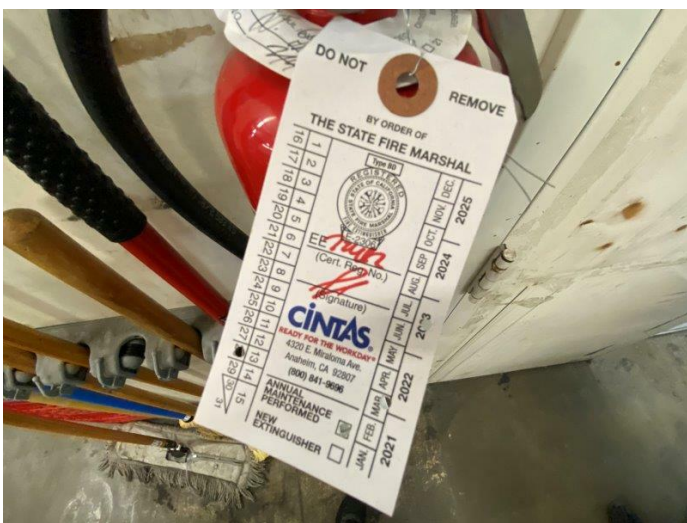
53. Up to date inspection tag on the fire extinguisher

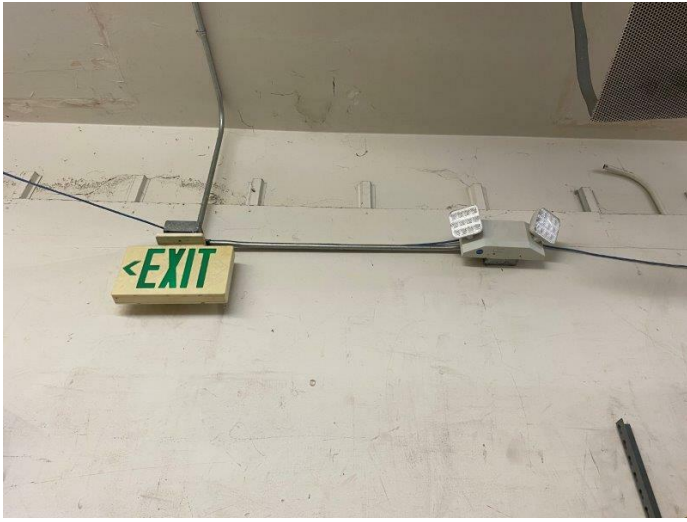
55. Emergency lighting and exit signage
