PROPERTY CONDITION REPORT

11021 West Pico Boulevard
11021 West Pico Boulevard
Los Angeles, California 90064

Report Date
September 11, 2023

Partner Project Number:
23-419894.1

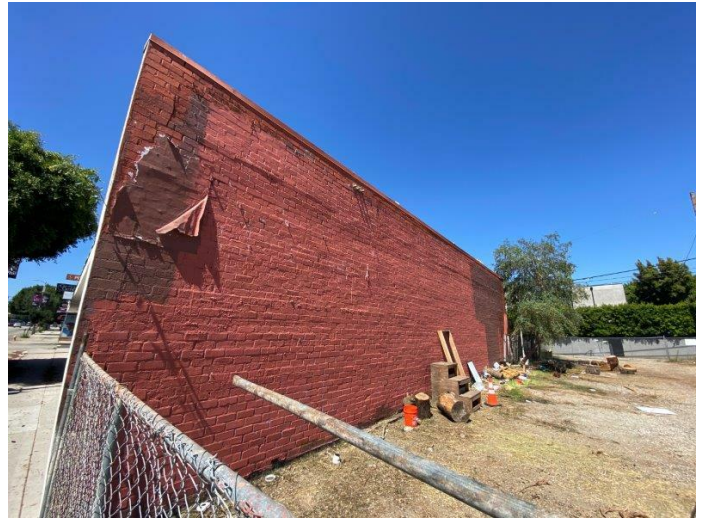
2. Eastern exterior facade

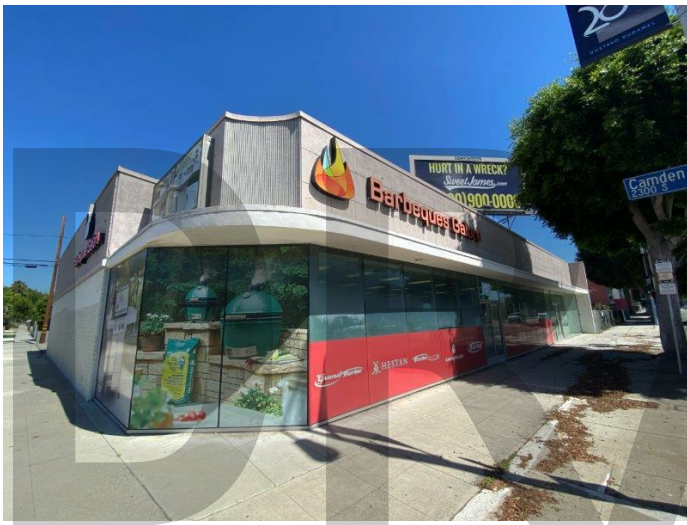
3. Southern exterior façade

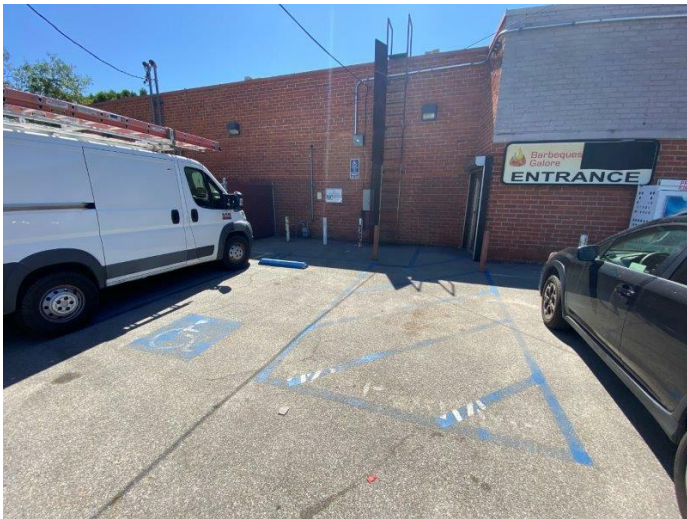
7. ADA parking

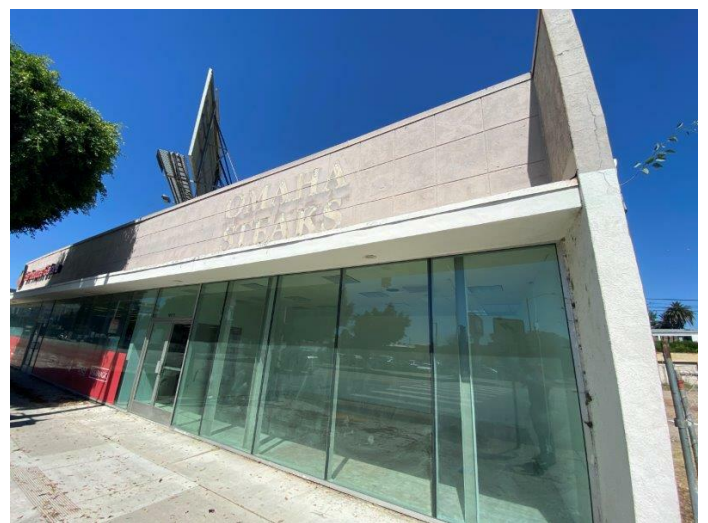
24. Storefront window system

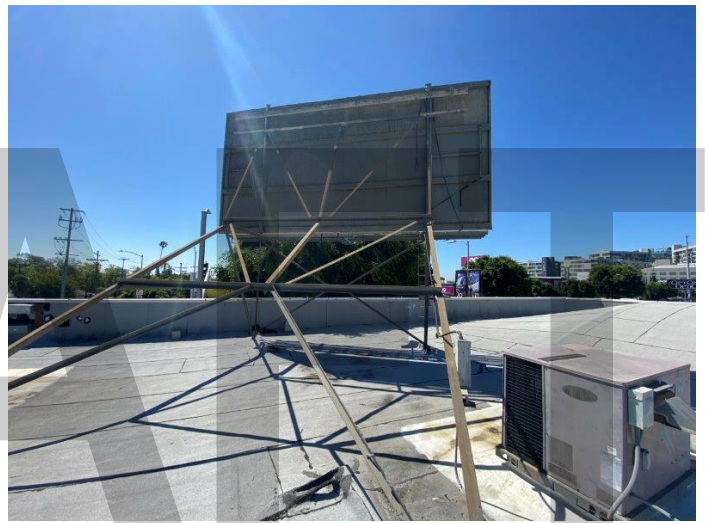
40. Billboard

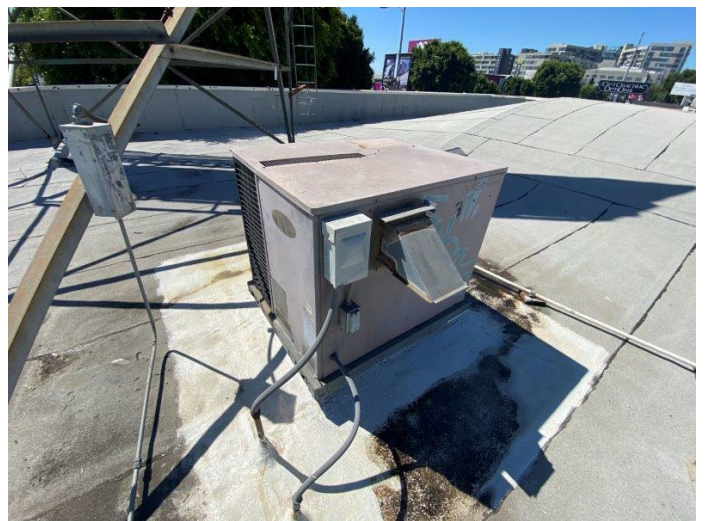
48. Single packaged heat pump

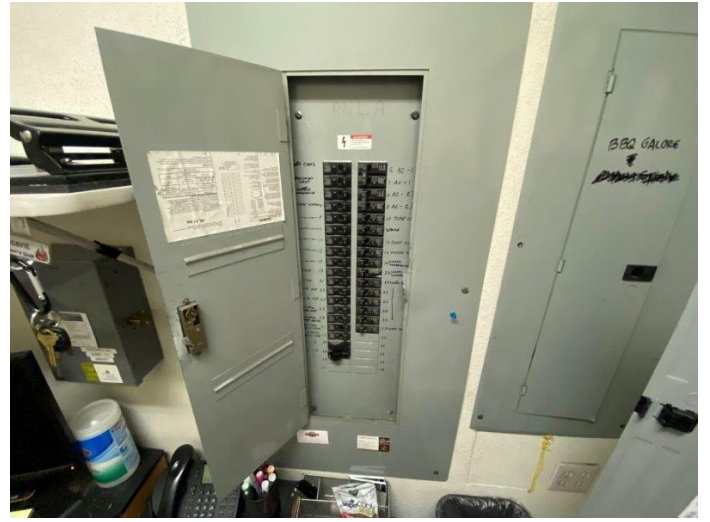
50. Electrical subpanel

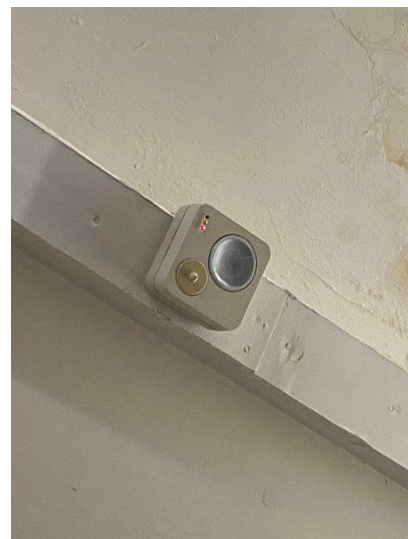
54. Smoke detector

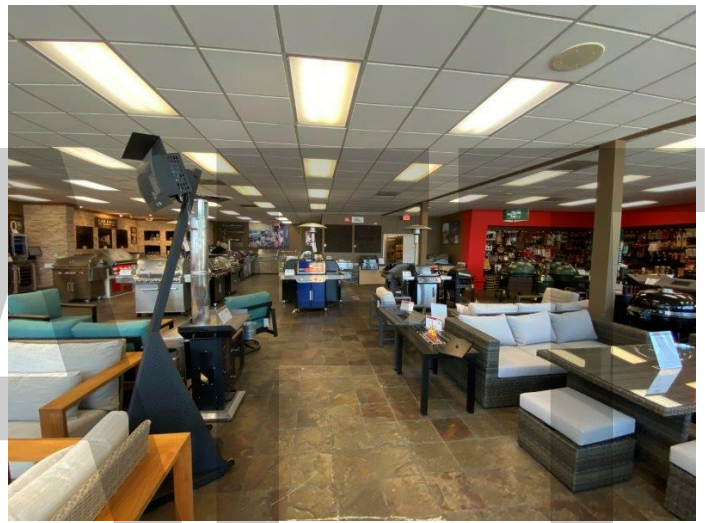
58. Interior finishes in the retail space

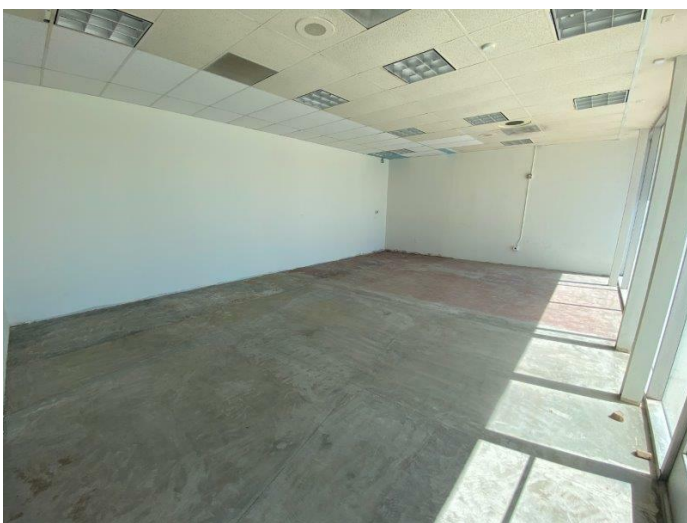
59. Interior finishes in the retail space

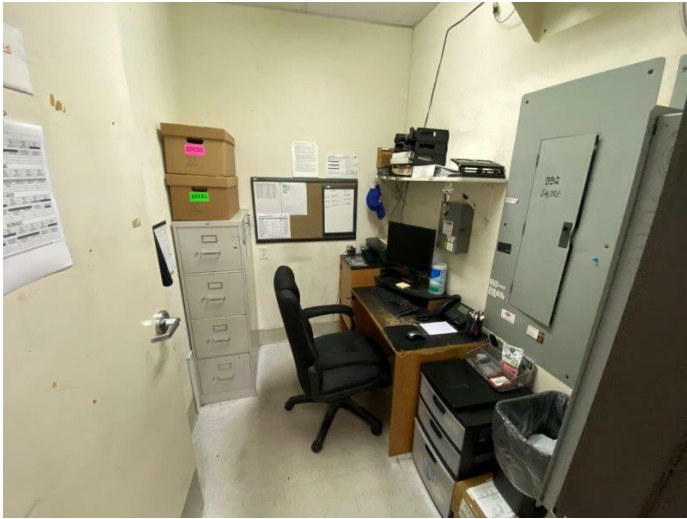
61. Management office

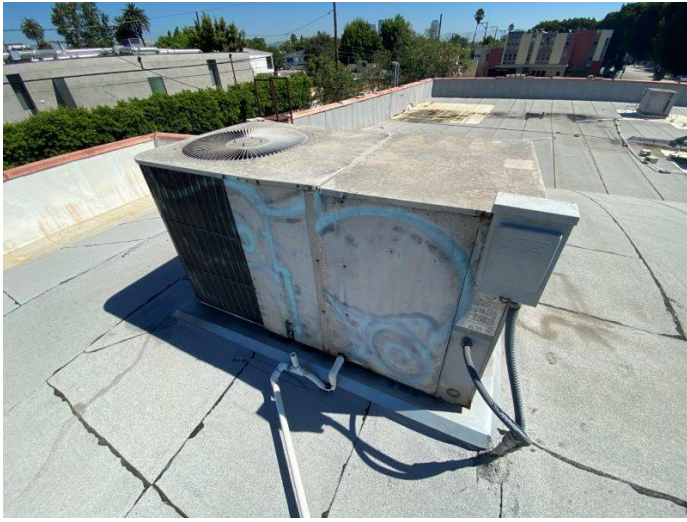
73. Packaged unit beyond useful life (28 years old)
